# **LABORATORY MEASUREMENT OF THE REDUCTION OF TRANSMITTED IMPACT SOUND OF A FLOOR COVERING**

**Test Report ID. T2605-3:**

**Reduction of impact sound pressure level according to ISO 10140-3**  
**Laboratory measurements of the reduction of transmitted impact sound by floor coverings on a heavyweight reference floor**

Client: **Belgotex NZ Ltd.**

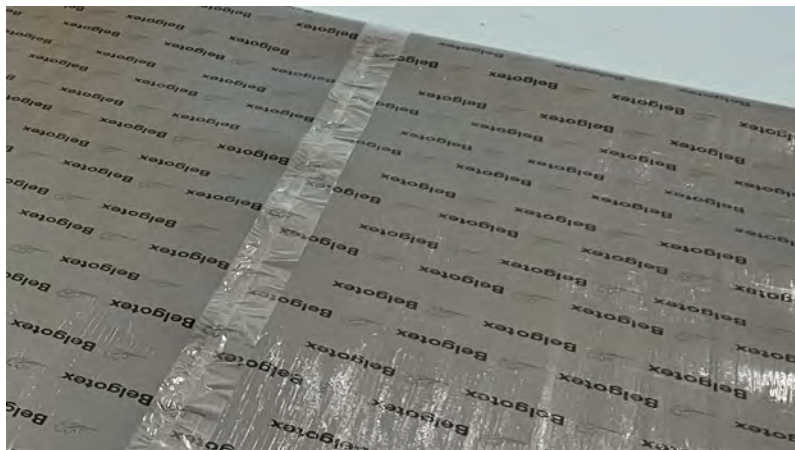
Figure 2.1: *Belgotex Aqua Elite* underlay showing self adhesive tape system

**Sample:** *Parky 10mm* Hardened timber flooring (standard plank size: 2.05 m(L) x 0.233 m(W) x 0.010 m thickness) planks assembled together and cut to cover the reference floor slab. Flooring loose laid on 2.5 mm *Belgotex Aqua Elite* floating floor underlay butted together and adhered to each other with proprietary taping system. *Belgotex Aqua Elite* loose laid on concrete reference floor

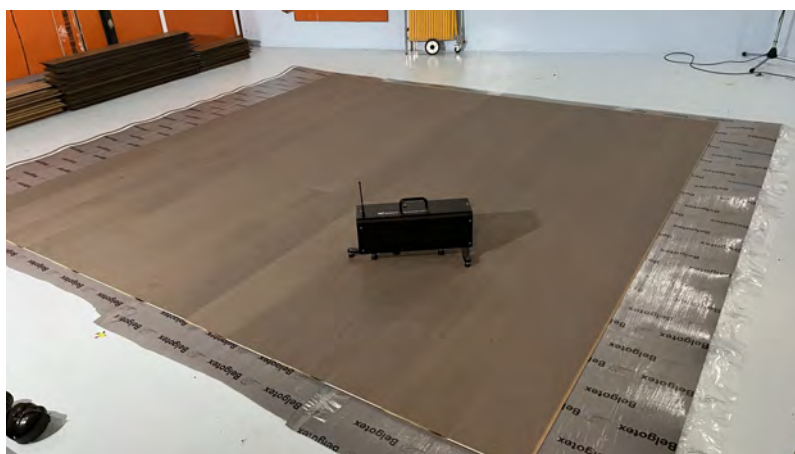
Figure 2.2: *Parky 10mm* finished floor system under test

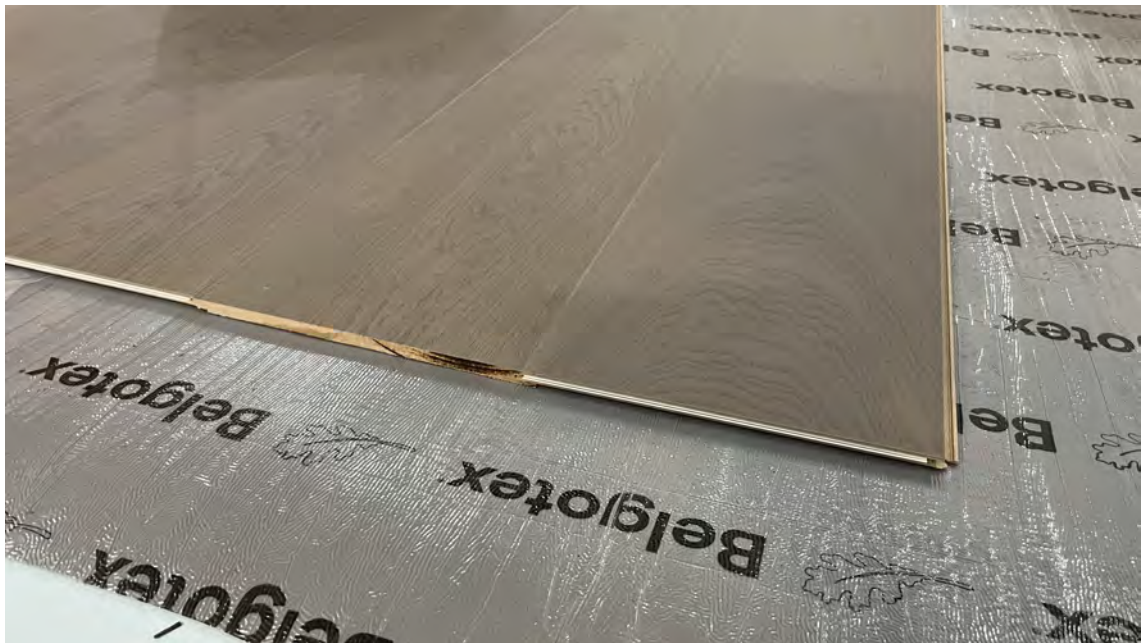
Figure 2.3: Flooring and underlay section detail
