# **LABORATORY MEASUREMENT OF THE REDUCTION OF TRANSMITTED IMPACT SOUND OF A FLOOR COVERING**

**Test Report ID. T2605-5:**

Belgotex NZ Limited  
25 Leslie Hills Drive,  
Riccarton, Christchurch 8011

**Reduction of impact sound pressure level according to ISO 10140-3**  
**Laboratory measurements of the reduction of transmitted impact sound by floor coverings on a heavyweight reference floor**

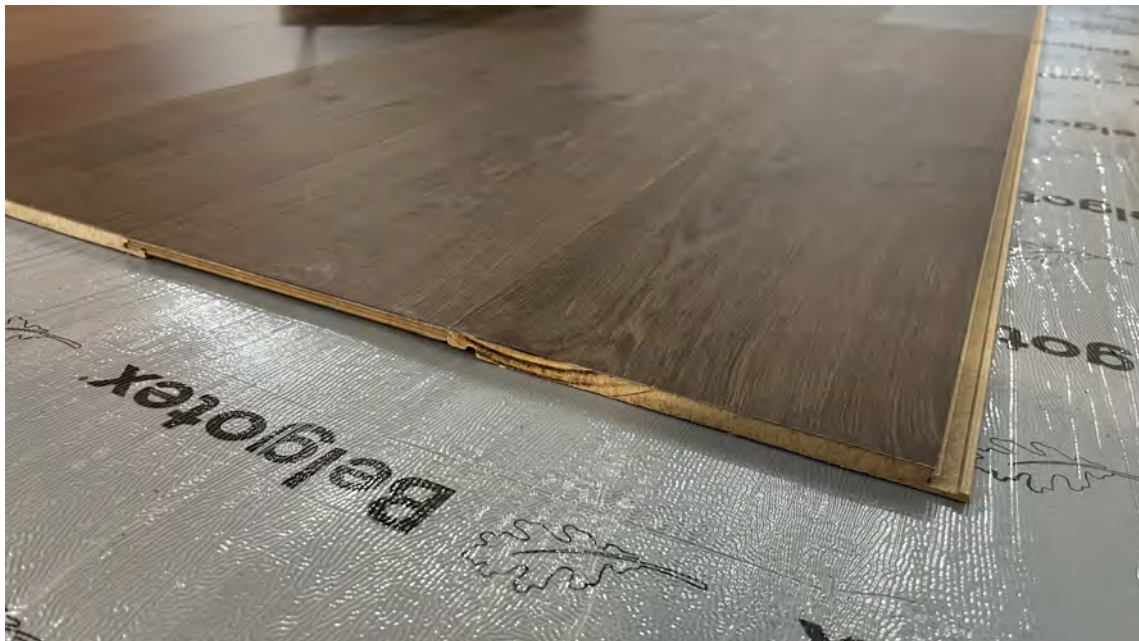
Figure 2.3: Flooring section detail

**Sample:** *Beljin 11.3mm* Hardened timber flooring (standard plank size: 2.2 m(L) x 0.206 m(W) x 0.0113 m thickness) planks assembled together and cut to cover the reference floor slab. Flooring loose laid on 2.5 mm *Belgotex Aqua Elite* floating floor underlay butted together and adhered to each other with proprietary taping system. *Belgotex Aqua Elite* loose laid on concrete reference floor
