LABORATORY MEASUREMENT OF THE REDUCTION OF TRANSMITTED IMPACT SOUND OF A FLOOR COVERING

Test Report ID. T2605-2:

LABORATORY MEASUREMENT OF THE REDUCTION OF TRANSMITTED IMPACT SOUND BY FLOOR COVERINGS ON A STANDARD FLOOR

Client: *Belgotex NZ Ltd.*

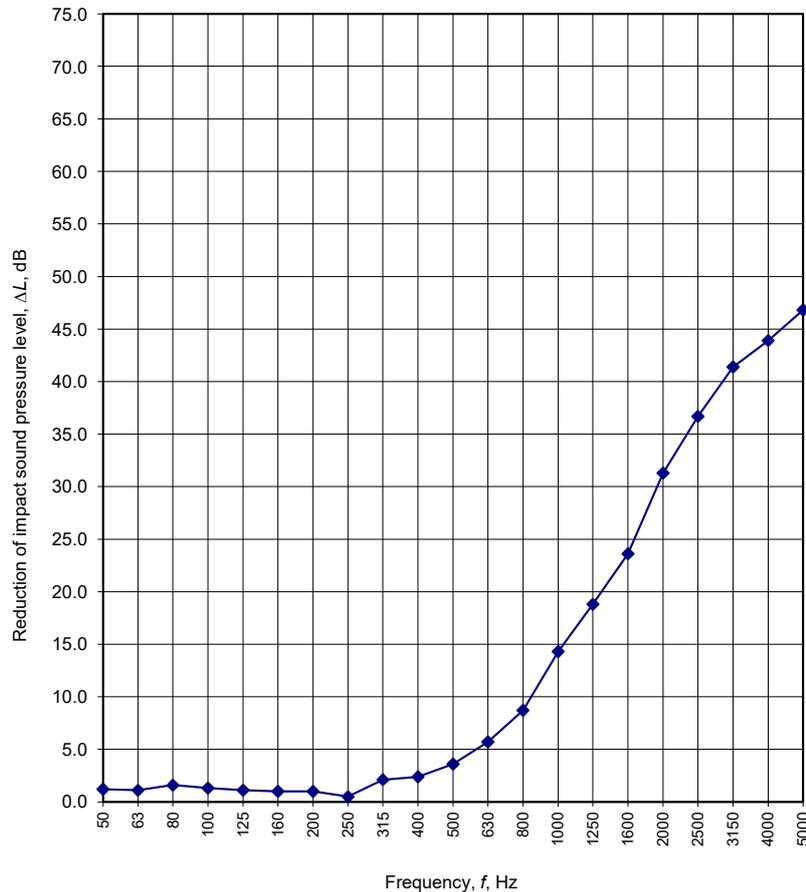
Frequency <i>f</i> Hz	<i>L_{n,0}</i> One-third octave dB	ΔL One-third octave dB
50	55.9	1.2
63	50.1	1.1
80	58.8	1.6
100	63.9	1.3
125	66.1	1.1
160	66.8	1.0
200	68.5	1.0
250	70.2	0.5
315	72.6	2.1
400	70.3	2.4
500	74.4	3.6
630	72.6	5.7
800	71.3	8.7
1000	71.3	14.3
1250	72.2	18.8
1600	72.1	23.6
2000	72.9	31.3
2500	72.9	36.7
3150	72.6	41.4
4000	70.8	43.9
5000	67.3	46.8

$\Delta L_w = 15$ dB

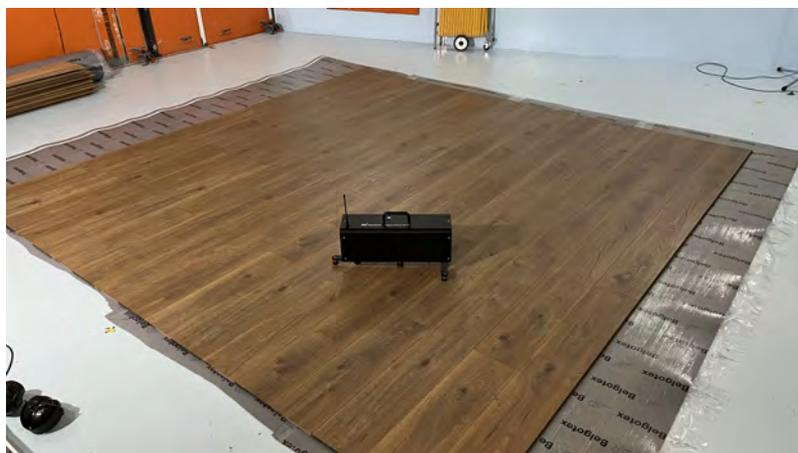
Figure 2.2: *Finsa 12mm* finished floor system under test

Sample: *Finsa 12mm* Laminate flooring (standard plank size: 1.331 m(L) x 0.194 m(W) x 0.008 m thickness) planks assembled together and cut to cover the reference floor slab. Laminate flooring loose laid on 2.5 mm *Belgotex Aqua Elite* floating floor underlay butted together and adhered to each other with proprietary taping system. *Belgotex Aqua Elite* loose laid on concrete reference floor

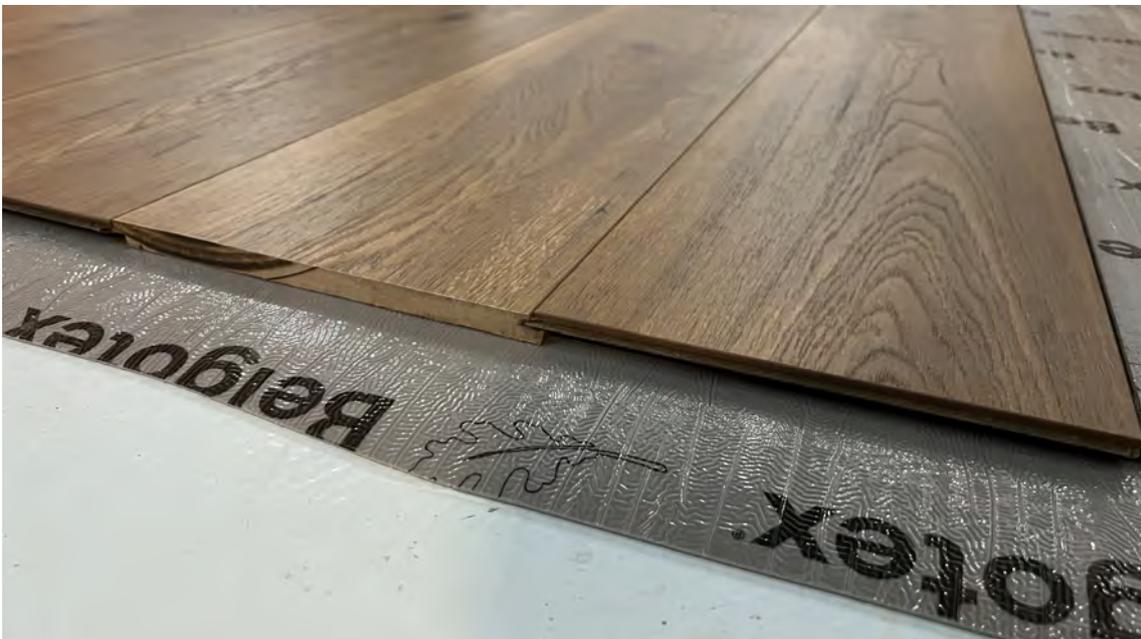
Figure 2.3: Flooring and underlay section detail

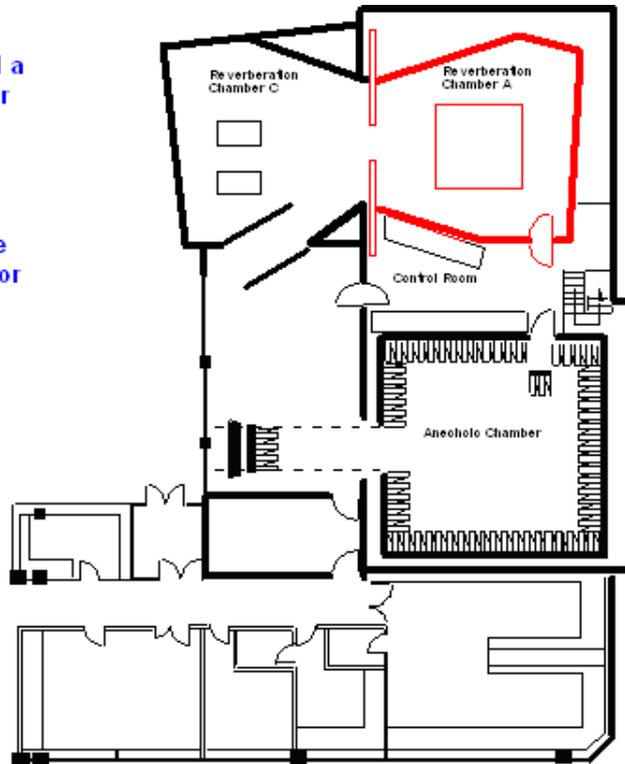
Figure 5.1: Acoustics Testing Service, The red lines show chambers used in measurements

There are three large interconnected reverberation chambers at the Acoustics & Vibration Research Centre (AVRC), two at ground level (Chambers C and A) and the third (Chamber B) below A.

All three reverberation chambers may be described as hexagonal prisms; each having 6 vertical sided walls, perpendicular to the floor. The roofs of chamber A and C are plane, but inclined at 12 degrees from horizontal. Chamber B has a plane, horizontal roof which is the floor of chamber A above it. The floor of chamber B is also horizontal, but has two angled sections at its north west and south east ends. The centre section is horizontal because a floor jack is installed there. The floor jack may be raised hydraulically to the ceiling of chamber B, the centre of which consists of a floor plug between the two chambers. This plug may be disconnected from chamber A and lowered down into chamber B, leaving a 3.2m x 3.2m opening between the two chambers. This allows for the measurement of airborne and impact insulation of floor and roof elements.

The three Reverberation Chambers are linked by heavy steel doors and a removable Standard Industrial Floor Section which is removed and repositioned by a hydraulic hoist. The three chambers are vibration isolated from one another so that sound can only pass from one to the other via the intervening Test Wall or Test Floor/Ceiling Section.
