LABORATORY MEASUREMENT OF THE REDUCTION OF TRANSMITTED IMPACT SOUND OF A FLOOR COVERING

Test Report ID. T2605-1:

LABORATORY MEASUREMENT OF THE REDUCTION OF TRANSMITTED IMPACT SOUND BY FLOOR COVERINGS ON A STANDARD FLOOR

Client: *Belgotex NZ Ltd.*

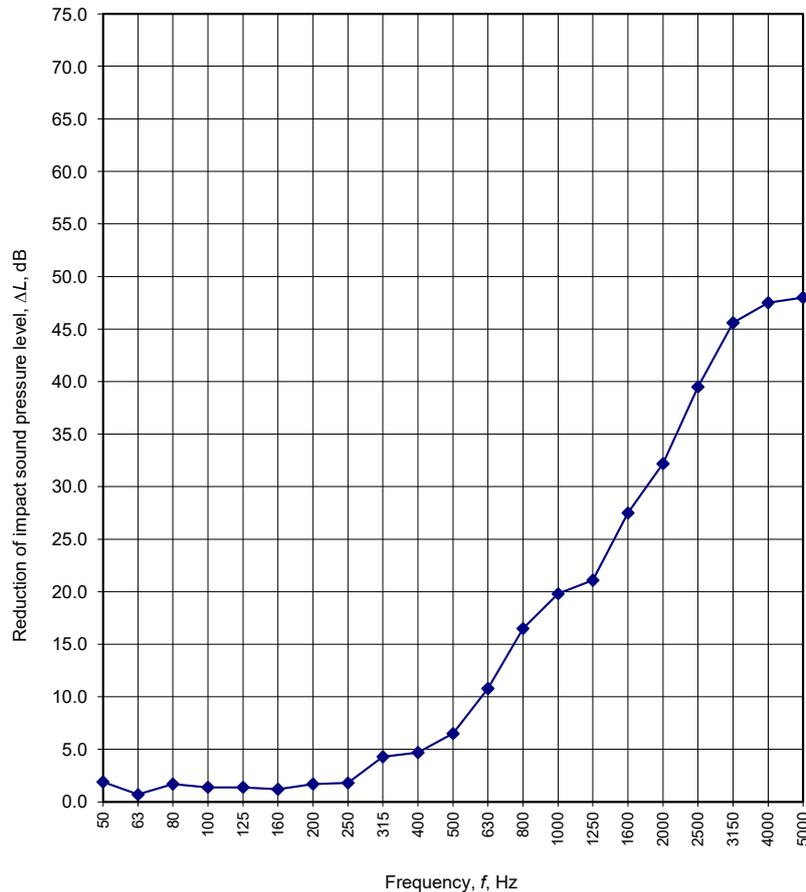
| Frequency <i>f</i> Hz | <i>L_{n,0}</i> One-third octave dB | ΔL One-third octave dB |

Rating according to ISO 717-2:

$\Delta L_w = 17$ dB

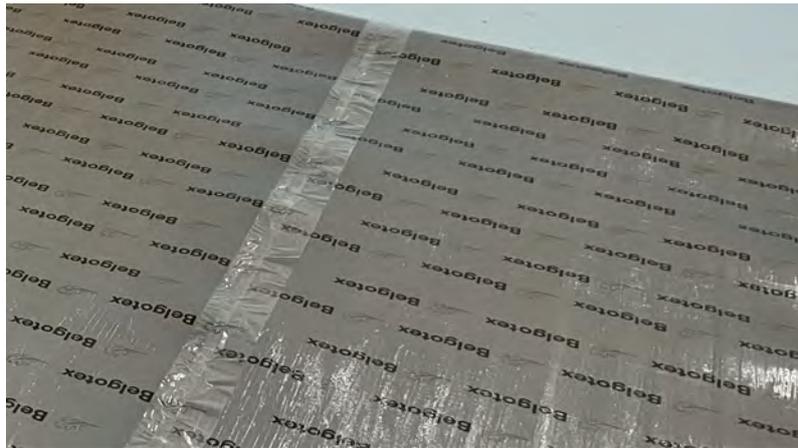
Figure 2.1: *Belgotex Aqua Elite* underlay showing self adhesive tape system

Sample: *Finsa 8mm* Laminate flooring (standard plank size: 1.331 m(L) x 0.194 m(W) x 0.012 m thickness) planks assembled together and cut to cover the reference floor slab. Laminate flooring loose laid on 2.5 mm *Belgotex Aqua Elite* floating floor underlay butted together and adhered to each other with proprietary taping system. *Belgotex Aqua Elite* loose laid on concrete reference floor

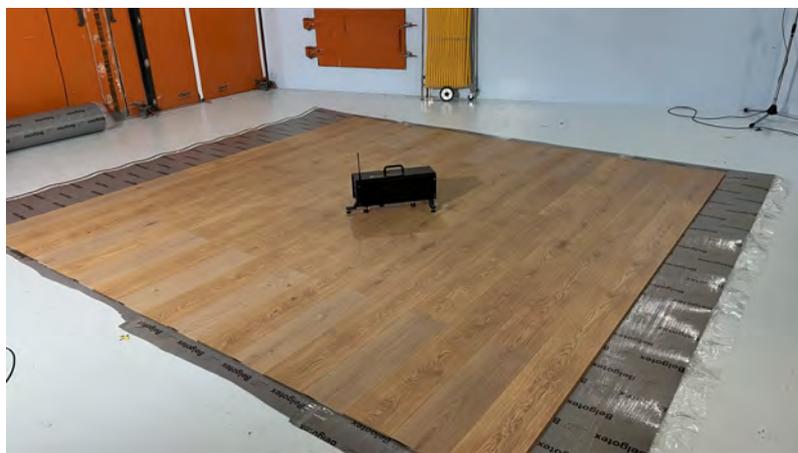
Figure 2.2: *Finsa 8mm* finished floor system under test

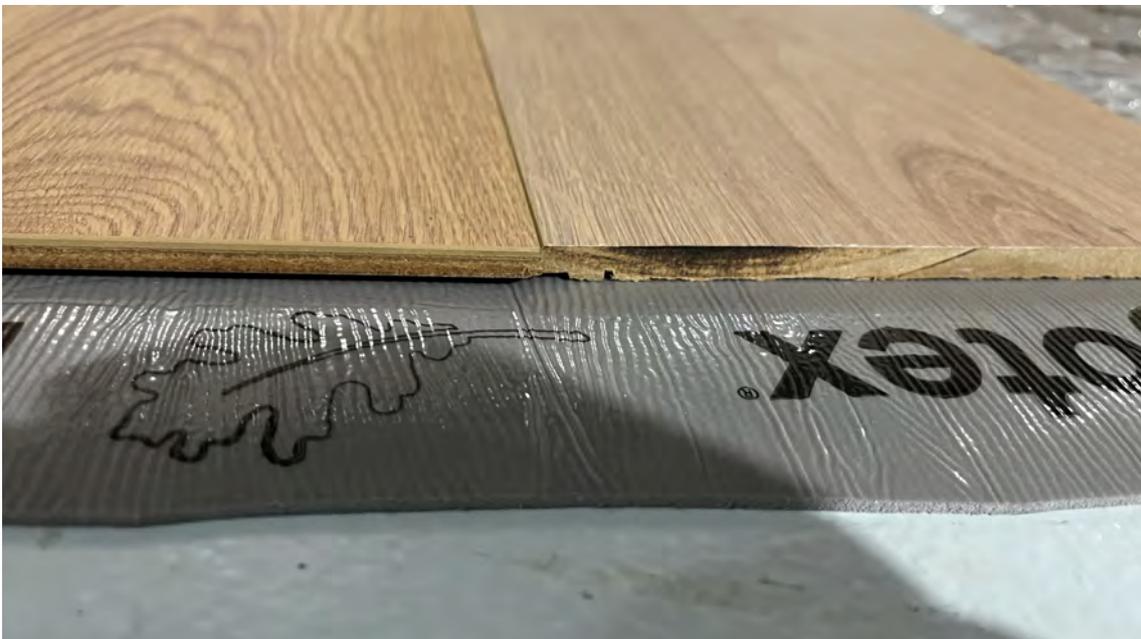
Figure 2.3: Flooring and underlay section detail

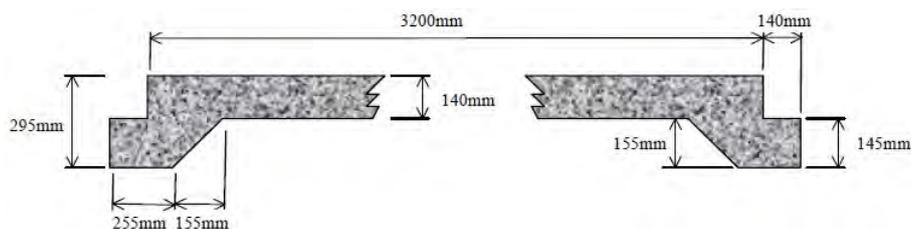
Figure 4.1: Floor/ceiling system

The floor covering is installed on a concrete floor plug that is positioned in the opening between two large reverberation chambers – chambers A and B. These chambers are vibration isolated from each other, which results in a structural discontinuity at the middle of the test opening. The concrete floor plug is made of concrete reinforced with steel and is covered with a layer of hard resin. The dimensions of the floor plug are given in the following elevation diagram. If the floor covering is flexible, a minimum of three samples to be tested are laid by the client following the techniques normally used in practice for that type of floor covering, with the constraint that the concrete floor plug be protected by a layer of thin self adhesive plastic tape if necessary.

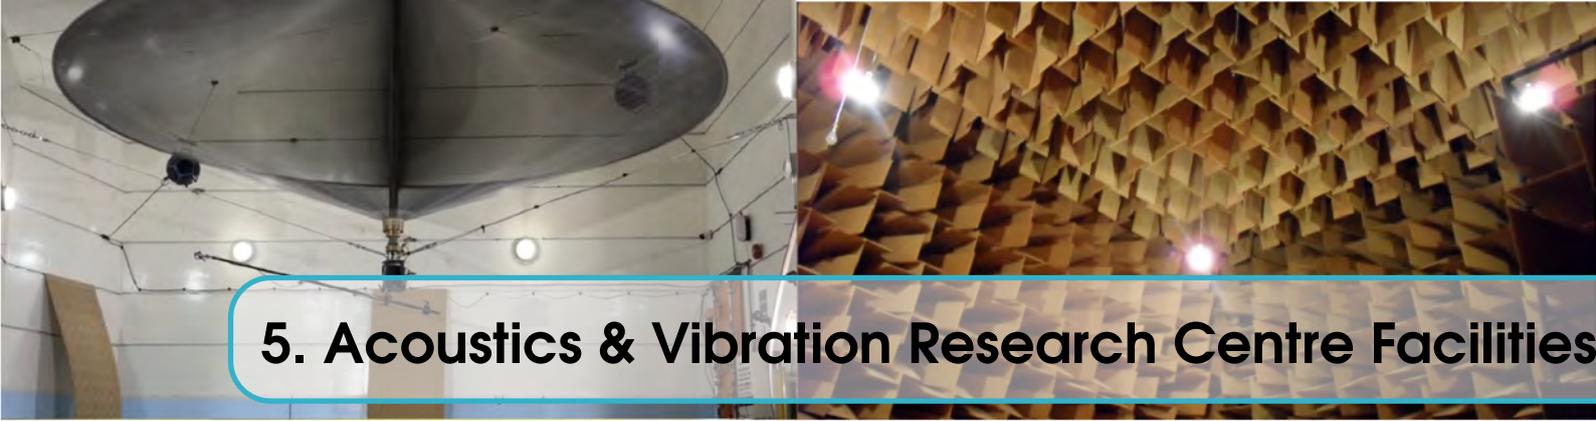
The normalized impact sound pressure levels are obtained in accordance with the recommendations of ISO standard 10140-3 “Measurements of impact sound insulation.” The NOR277 tapping machine is placed sequentially in four different positions on the floor. The impact sound pressure level is measured in the room below the floor, using a rotating microphone, in third octave frequency bands. The impact sound pressure levels are normalized against the room absorption. The room absorption is calculated from the reverberation time and room volume. The reverberation time is measured from the decay of a steady state sound field and tested according to ISO 354. Corrections are applied, where necessary, for airborne sound transmission and background noise. The airborne sound transmission is determined using a loudspeaker and the microphone.

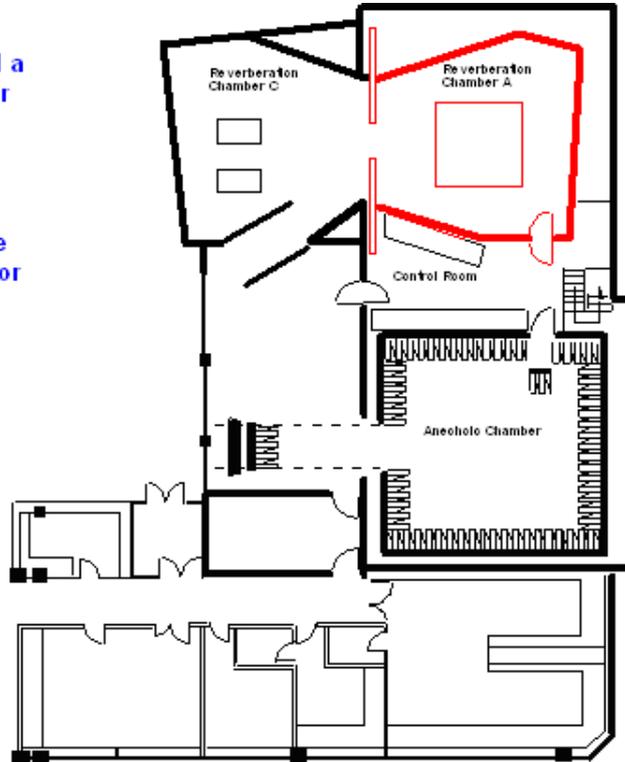
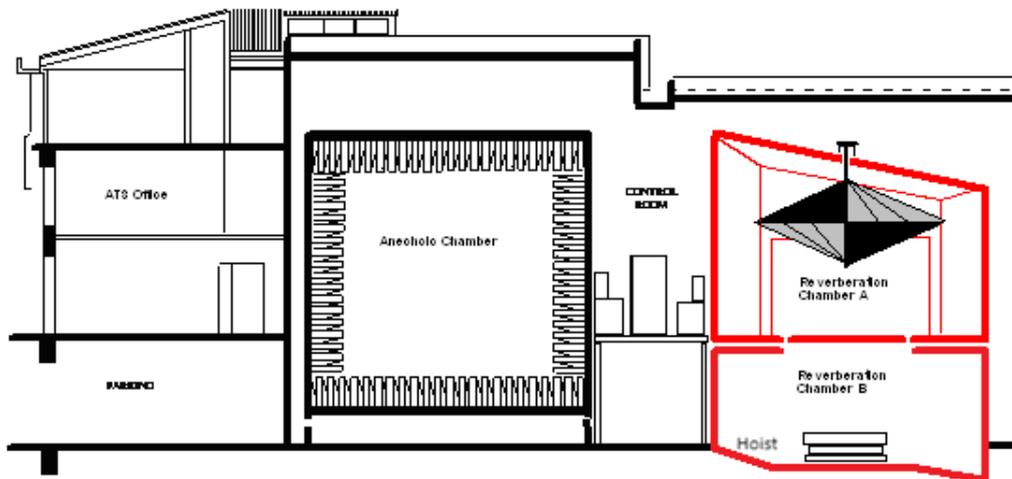
Figure 5.1: Acoustics Testing Service, The red lines show chambers used in measurements

There are three large interconnected reverberation chambers at the Acoustics & Vibration Research Centre (AVRC), two at ground level (Chambers C and A) and the third (Chamber B) below A.

All three reverberation chambers may be described as hexagonal prisms; each having 6 vertical sided walls, perpendicular to the floor. The roofs of chamber A and C are plane, but inclined at 12 degrees from horizontal. Chamber B has a plane, horizontal roof which is the floor of chamber A above it. The floor of chamber B is also horizontal, but has two angled sections at its north west and south east ends. The centre section is horizontal because a floor jack is installed there. The floor jack may be raised hydraulically to the ceiling of chamber B, the centre of which consists of a floor plug between the two chambers. This plug may be disconnected from chamber A and lowered down into chamber B, leaving a 3.2m x 3.2m opening between the two chambers. This allows for the measurement of airborne and impact insulation of floor and roof elements.

The three Reverberation Chambers are linked by heavy steel doors and a removable Standard Industrial Floor Section which is removed and repositioned by a hydraulic hoist. The three chambers are vibration isolated from one another so that sound can only pass from one to the other via the intervening Test Wall or Test Floor/Ceiling Section.
