# **LABORATORY MEASUREMENT OF THE REDUCTION OF TRANSMITTED IMPACT SOUND OF A FLOOR COVERING**

**Test Report ID. T2605-4:**

**Reduction of impact sound pressure level according to ISO 10140-3**  
**Laboratory measurements of the reduction of transmitted impact sound by floor coverings on a heavyweight reference floor**

**Sample:** *Beljin 9.2mm* Hardened timber flooring (standard plank size: 1.17 m(L) x 0.151 m(W) x 0.0092 m thickness) planks assembled together and cut to cover the reference floor slab. Flooring loose laid on 2.5 mm *Belgotex Aqua Elite* floating floor underlay butted together and adhered to each other with proprietary taping system. *Belgotex Aqua Elite* loose laid on concrete reference floor

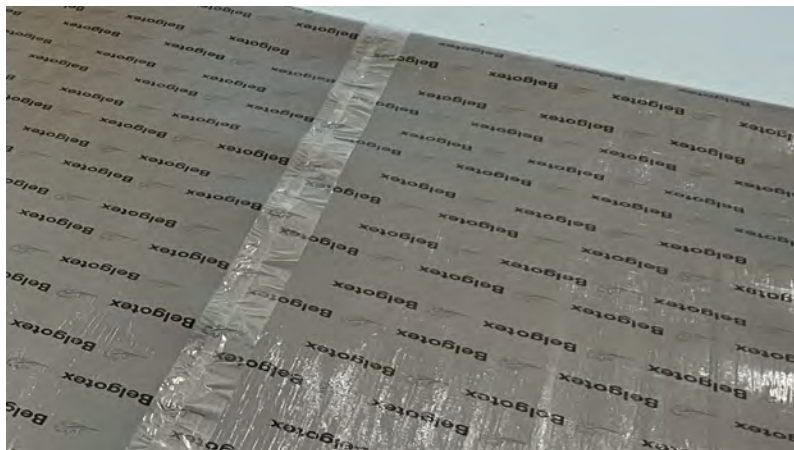
Figure 2.1: *Belgotex Aqua Elite* underlay showing self adhesive tape system

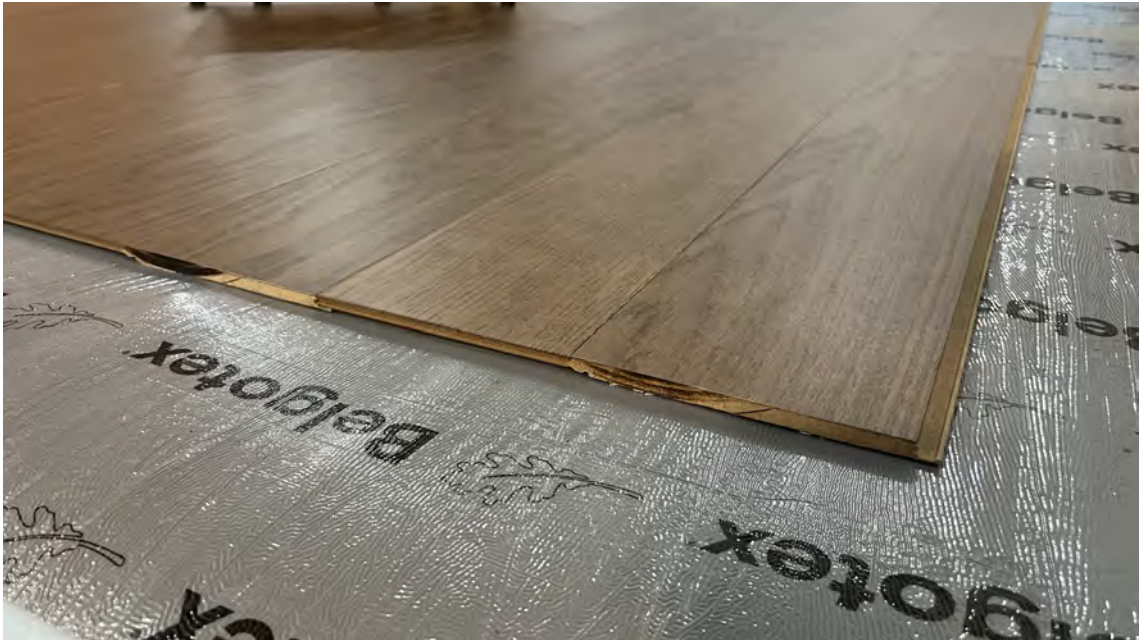
Figure 2.3: Flooring section detail
